AEROSPACE REPORT NO.
TR-93(3478)-1

Investigation of ACC/CCI Tunnel Diodes

In October of 1991, a DMSP radio-frequency detector in channel T2 of system B6 failed during testing. The detector module exhibited low output. Subsequent investigation initiated by Aerojet, the DMSP prime contractor, traced the problem to the tunnel diode in the detector. Tunnel diodes are used in a number of low-power microwave applications. The tunnel diodes are manufactured by Custom Control Components (CCI), and the detector modules by Advanced Control Components (ACC). Although ACC and CCI are separate companies "on paper," they share the same manufacturing facility and are not readily distinguishable by the casual observer. Destructive physical analyses carried out after the failure indicated that contaminants had been introduced during fabrication. Site visits at ACC/CCI by contractor and Aerospace personnel led to a general improvement of the manufacturing process with a concomitant improvement in detector reliability. A review of the available literature pointed to a tunnel-diode failure mechanism found some years ago by researchers at Comsat and led to a recommendation of an additional component

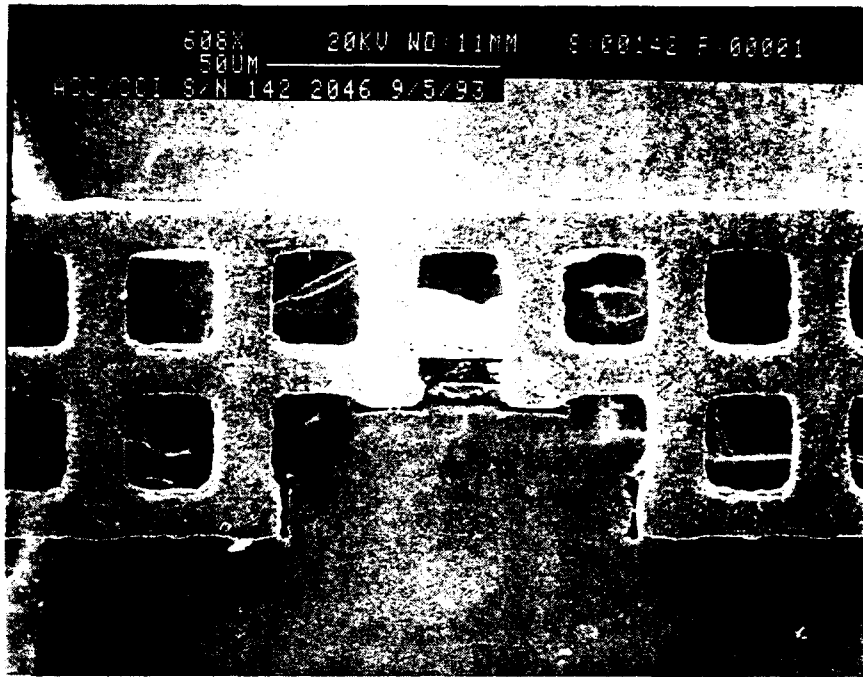
Diode S/N 142 is a particularly interesting case. The mesa of this diode, as received, was covered by epoxy. There was no sign of the graceful, tapering "stalk" that we have come to expect in tunnel diodes (Figures 19a,b). The device was etched in an oxygen plasma, and the epoxy removed — still with no obvious mesa. The Ge appears to have fractured. The ribbon appeared to have been "mashed down" along one edge, and it seemed that the view of the mesa might simply have been blocked by the ribbon. Using the FIB, the ribbon was cut away to better expose the mesa region (Figures 20a,b); still, no "stalk" could be seen. The other side of the ribbon was also cut away, and, again, a tapering stalk was not evident (Figures 21a,b).

Figure 20a. One side of the ribbon has been cut away by ion milling to better expose the ball-mesa contact (NASA device, S/N 142, 608 \times magnification).
